Offsite bespoke engineered stack replacement offers solutions in tight spaces.

CASE STUDY

Harcourt House, Tamworth.

Live Stack Replacement.

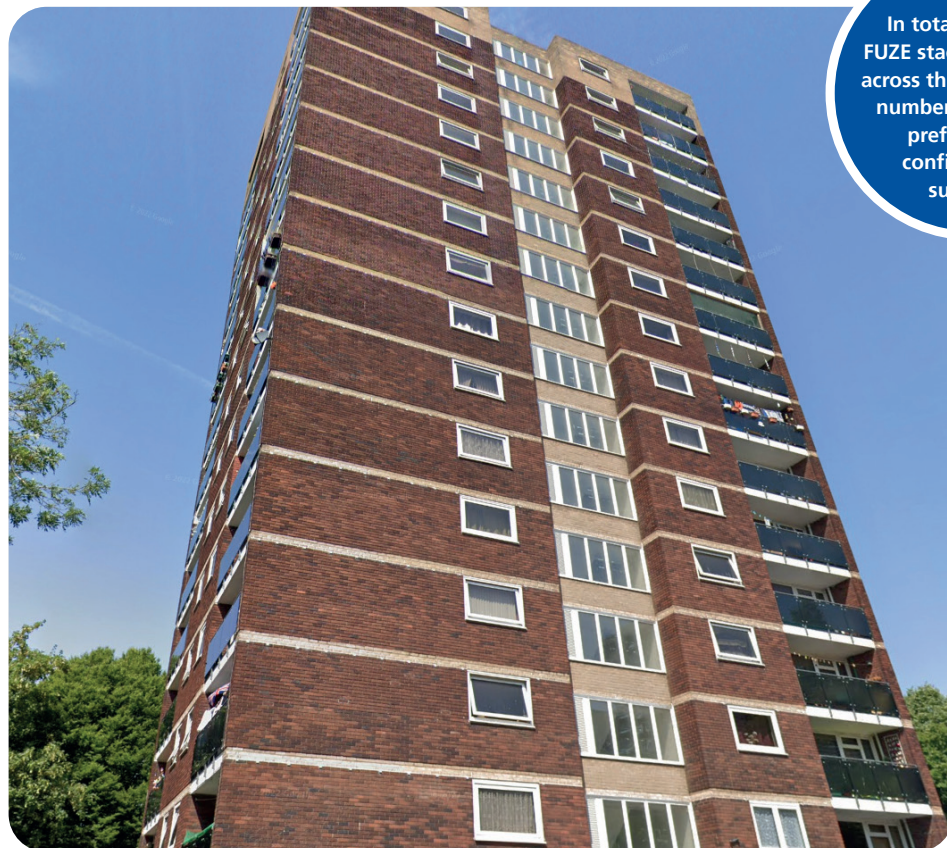
In total 60 Terrain FUZE stacks were used across this build with a number of different prefabricated configurations supplied.

In total 60 Terrain FUZE stacks were used across this build with a number of different prefabricated configurations supplied. To tackle the awkward location of the original stack, the replacements were supplied in two halves per property which enabled the installer to drop it easily into this existing space. Being in two pieces also allowed for an expansion joint to be put in the middle of the stack which made it fully rotatable so the installation team could place the access door exactly where they needed.
