# Polypipe's Ridgistorm-XL supplied to dairy processor to capture excess surface water

#### **CASE STUDY**

Cotteswold Dairy, Tewkesbury

Stormwater attenuation

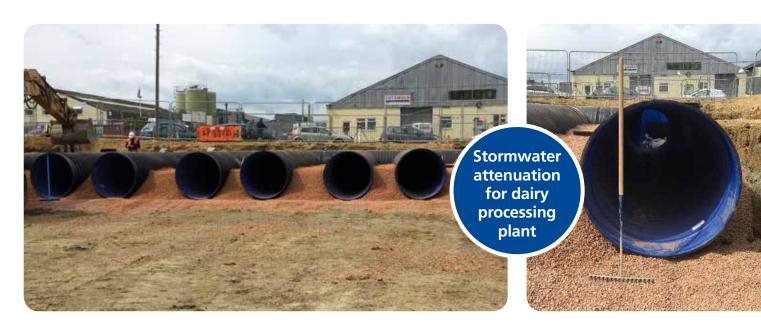
Over 250 metres of Polypipe's popular Ridgistorm-XL has been installed for the expansion of an established dairy processor that has been in operation since 1938.

As part of a large-scale renovation to increase yard space, Cotteswold Dairy has seen Polypipe's thermoplastic Ridgistorm-XL solution utilised to capture and attenuate excess surface water and potential milk leakages. Working closely alongside Vitruvius, the project's Construction and Cost Management team and main contractor Smith's of Gloucester, Polypipe fabricated over 250 metres of Ridgistorm-XL, incorporating a RIDGISTORMCheck Vortex Flow Control Chamber, to sit beneath the lorry park.

The complete system included 10 fabricated fittings, including 90° bends and double T

sections to aid water discharge at a consistent rate in to an existing water course. The spigot design of Polypipe's system and fittings made pipe alignment easy and fully compatible with the electro-fusion jointing method. This in turn led to a more efficient and guicker installation process.
